THE DISASTER OF THE GOETTINGEN-DEIDERODE MBP / MBT PLANT

Wolfgang H. STACHOWITZ AND Gregor ENTFELLNER

SUMMARY: During the accident of the Deiderode MBP/T in January 2006, large parts of the plant were destroyed and the material damage amounted to approx. 10,000,000 Euros. Besides the material damage, the breakdown cost and is continuing to cost up to seven-digit sums in Euro up to this point (beginning of April 2007). To find out the cause of damage and to ascertain who will pay the costs, the operator of the MBP/T, the "Abfallzweckverband Südniedersachsen" ("AS" for short), has arranged for independent proceedings for the taking of evidence at the Göttingen Regional Court ("Landgericht Göttingen"). Until now, this process advances very slowly, so that the cause of the accident has not finally been cleared up by the expert witnesses. The author Wolfgang H. Stachowitz, who, in this case, acts as an expert for the Gothaer insurance company of the AS, excludes an explosion as the cause. It appears as if the cause can be found in the interaction of several small deviations from the normal operation and normal design respectively. In April 2006, the author Wolfgang H. Stachowitz has s

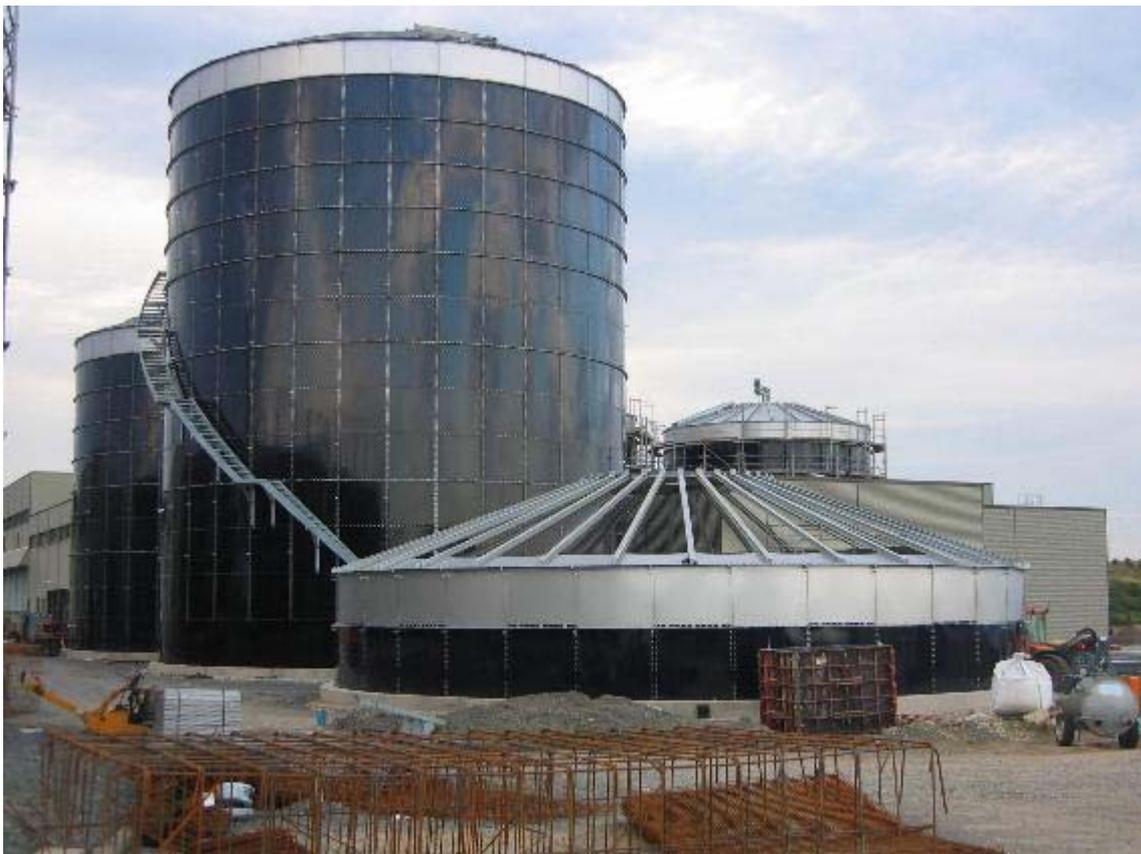
Figure 1. The three fermenters during the construction phase (Abfallzweckverband Südniedersachsen, 2005).

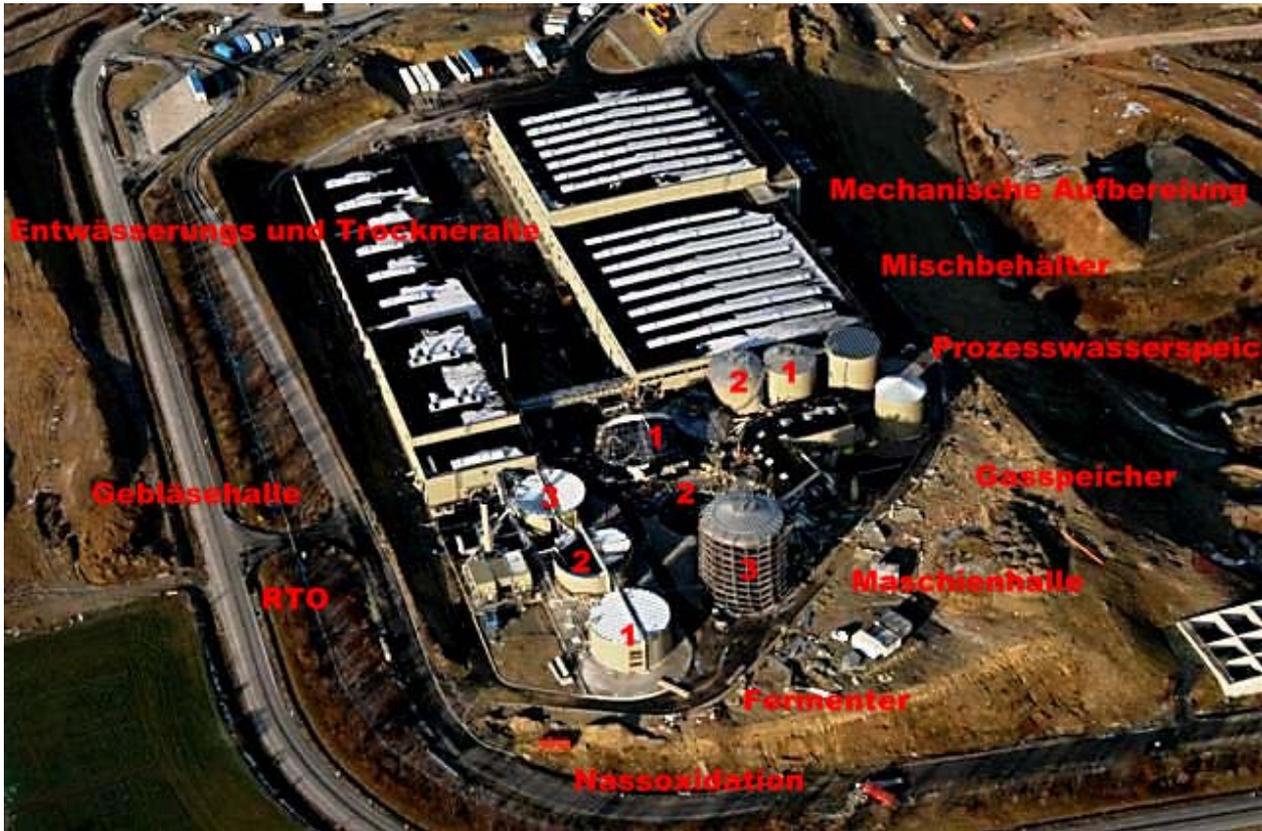
Figure 3. Aerial photo of the MBP-/ MBT-plant after the accident, showing the drawn layouts of the parts of the plant

During the accident, two of the three fermenters were completely destroyed. The third fermenter was pulled out of its anchor in the foundation and moved over 10 m. Most probably, it did not

collapse because it was empty.

The CHPs were crushed and "buried" by the rubble of the first and the second fermenter.

Rubble and / or the outflow fermenter contents destroyed the blending tanks, the machine house, the wet oxidation, the waste gas cleaning and the biological sulphur removal. One laboratory container was flushed away. In addition, damages to the halls, on the infrastructure and on the machines of the MBT could be ascertained.
